## Parkway Scuba

Atlas First Stage

Atlas second stage and Octopus

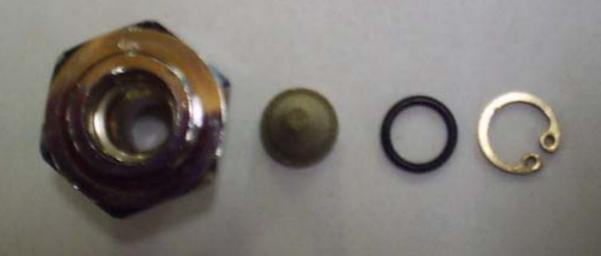
#### Remove Filter retainer, filter and O-ring

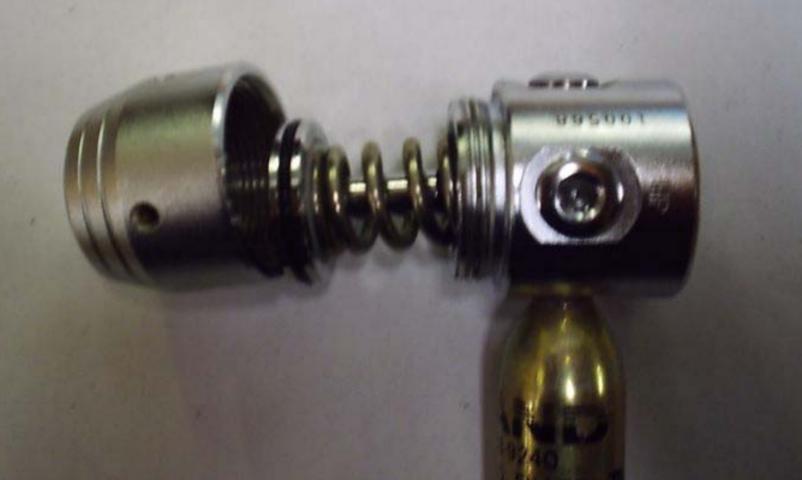
Remove Piston Cap and HP spring, HP Seat, Piston, Spacing Shims, HP Seat and O-Rings, LP and HP plugs

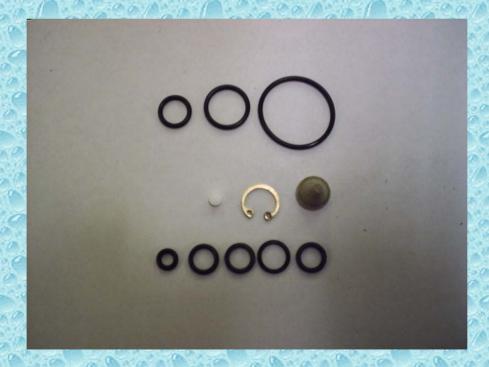
- Check the service Kit
- Replace all supplied o-rings

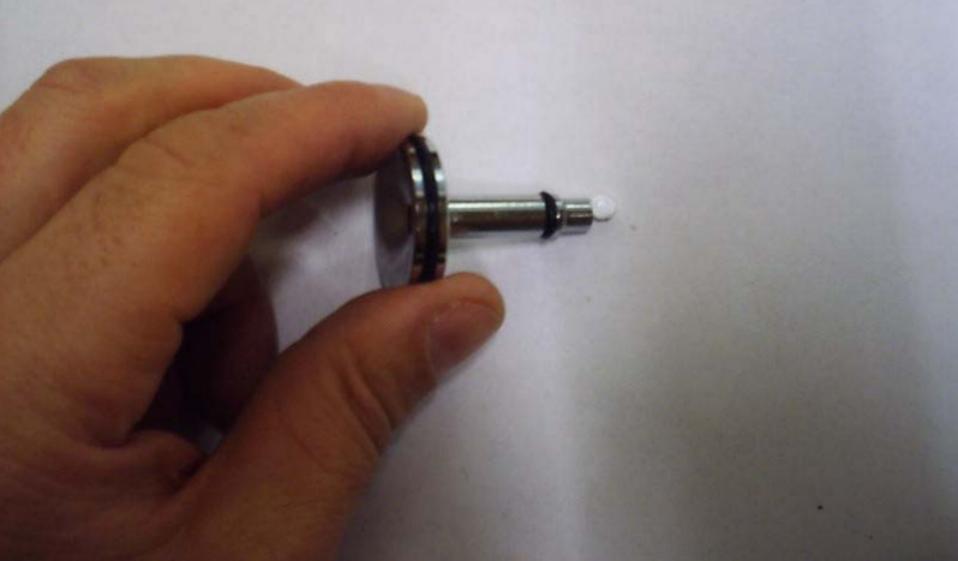
#### Insert new HP seat into the piston

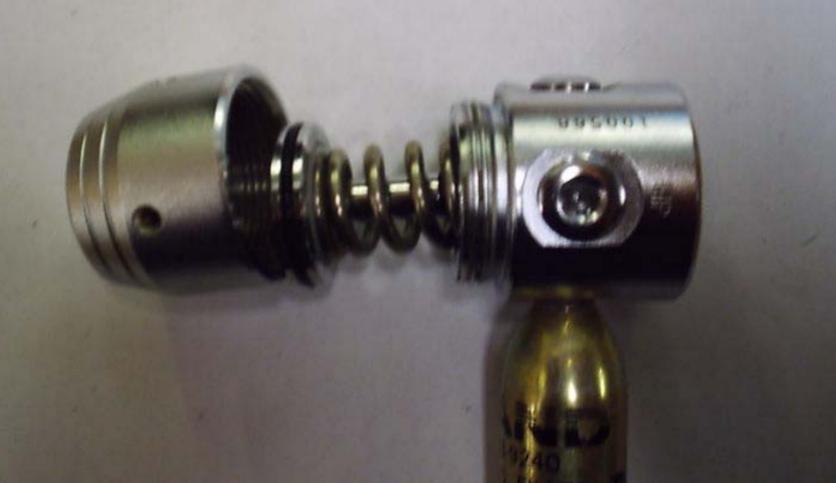
Insert piston through spacing shim, HP spring and into the regulator body

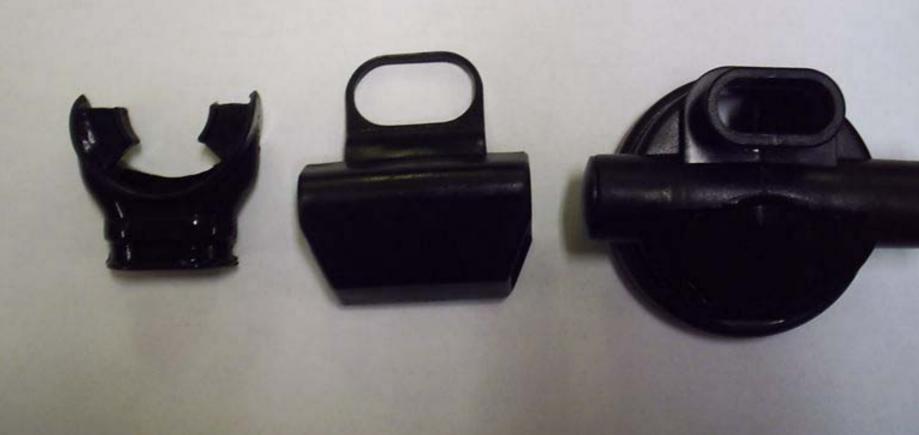
#### Remove Diaphragm retainer, Diaphragm, Mouthpiece and Exhaust Tee

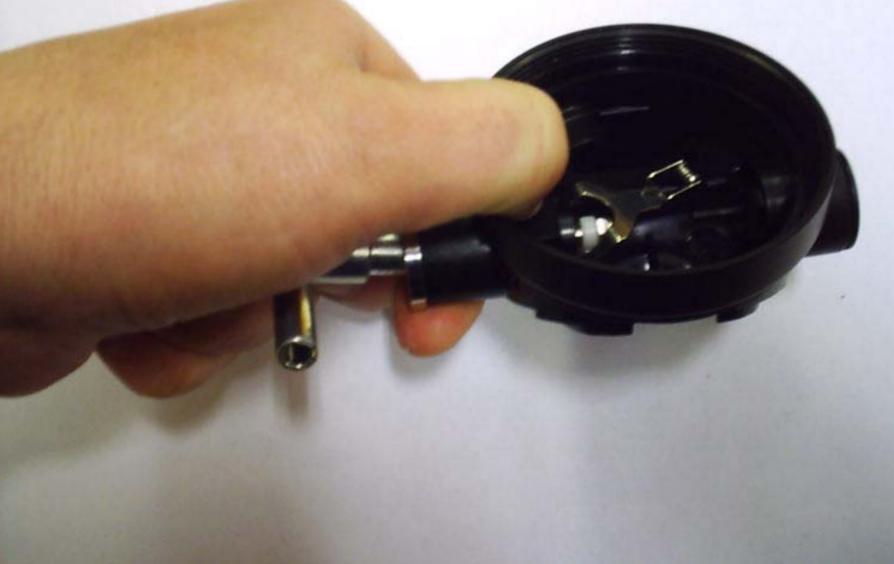
Remove Lever Arm by pushing seat carrier and pulling lever arm

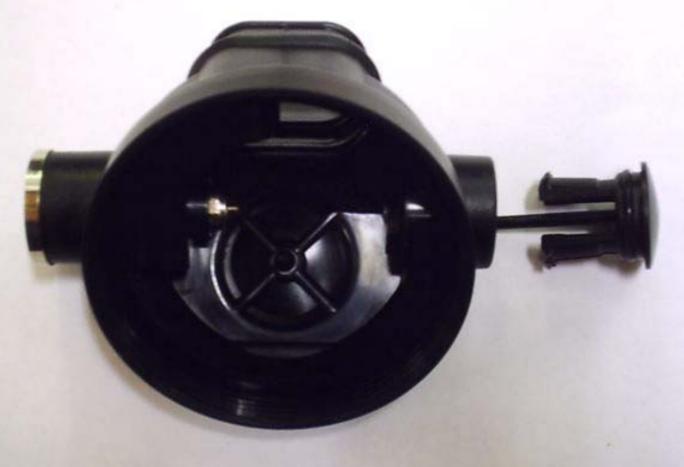
### Remove Side Plug

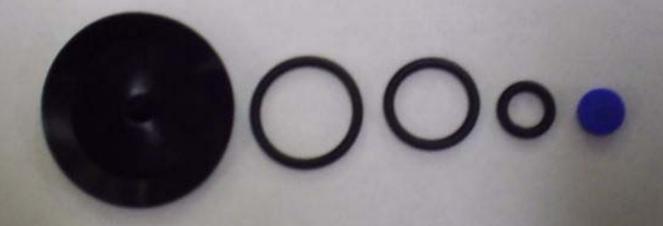
#### **Check Service Kit**

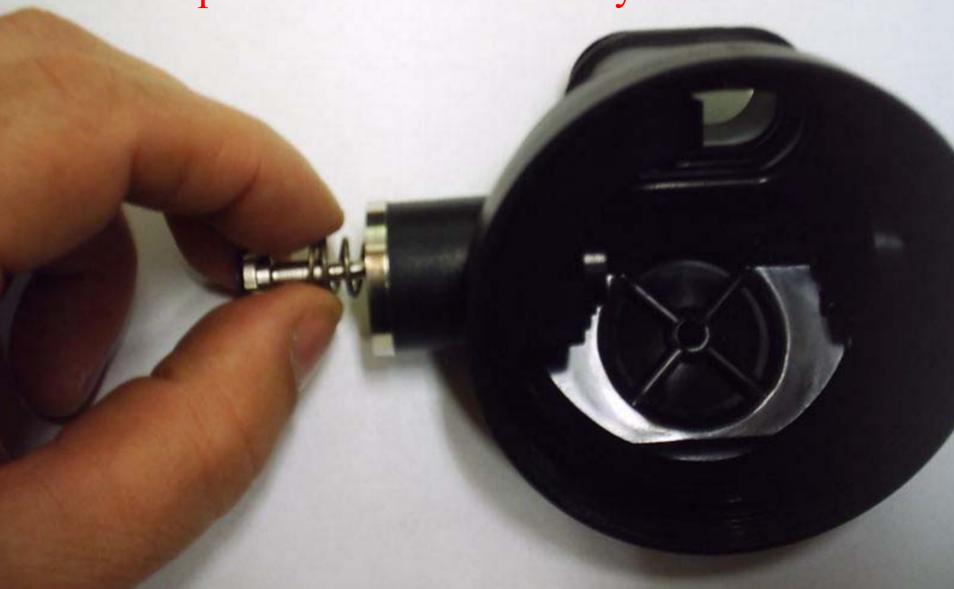
Insert Spring, LP Seat carrier, push carrier until threaded portion extends into body

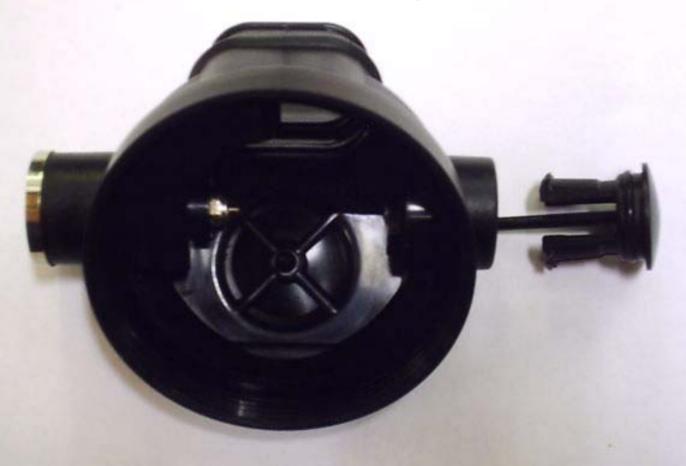
### Install Side Plug

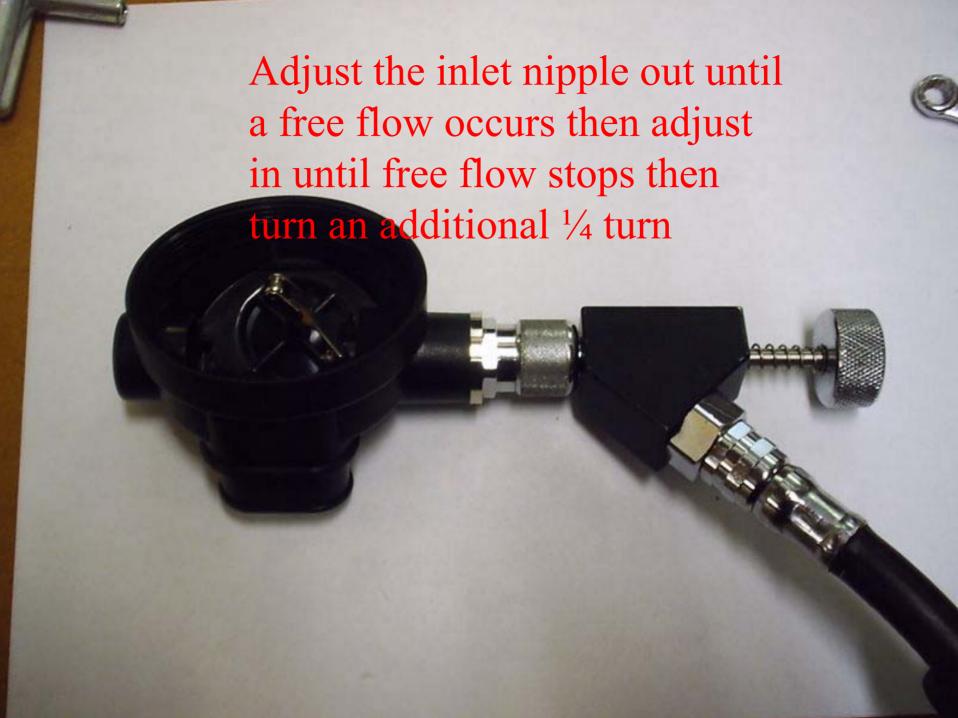
- Attach the 2<sup>nd</sup> stage to a LP air source
- Check that the 2<sup>nd</sup> Stage has no air leaks, if air is leaking the most likely cause is the unit has been assembled incorrectly or there is a defect in the inlet nipple
